LOCARCH SHELTER

Jean R. Saulnier, et al

Air Force Civil Engineering Center
Tyndall Air Force Base, Florida

May 1975

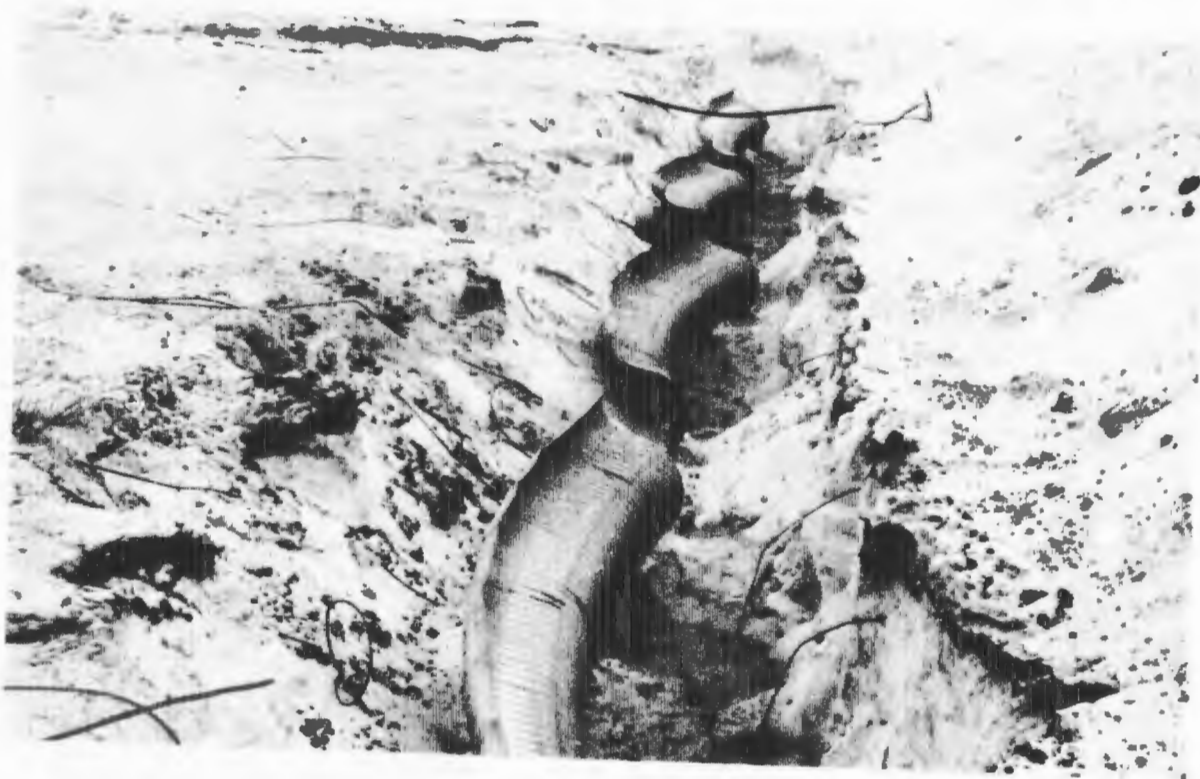
Figure 11 Anchor System Using Steel S' alter Liner Sections

The site that was chosen to erect the shelter was just east of the Field Technology facilities. The site was chosen because of the undulating sand that existed and could provide an extreme test as to the capability of the building to be erected over an 18-inch total difference in ground elevation for the length of the shelter. The contract did not provide for an anchoring system. It was initially envisioned to use the 4-inch arrowhead anchors that were in use in the Bare Base system. Because of the anticipated wind loading on the building and the number of arrowhead anchors it would take to secure the shelter in the uncompacted sandy soil, another anchoring system was devised as shown in Figure 11.

A trench was dug around the outside perimeter of the shelter and the steel shelter liner sections were placed in the trench with cables. The trench was backfilled and compacted leaving the cables extended above ground. The cables were then wrapped around the base rail and restrained the building movement if it was subject to extreme wind loads when erected. After the backfilling over the anchor systems and the area was brought to the desired elevations, the building layout and assembly was initiated. Figure 12 is a picture of the building components as they were received on pallets from Lockheed. The area where the shelter was erected, was just left of the components.

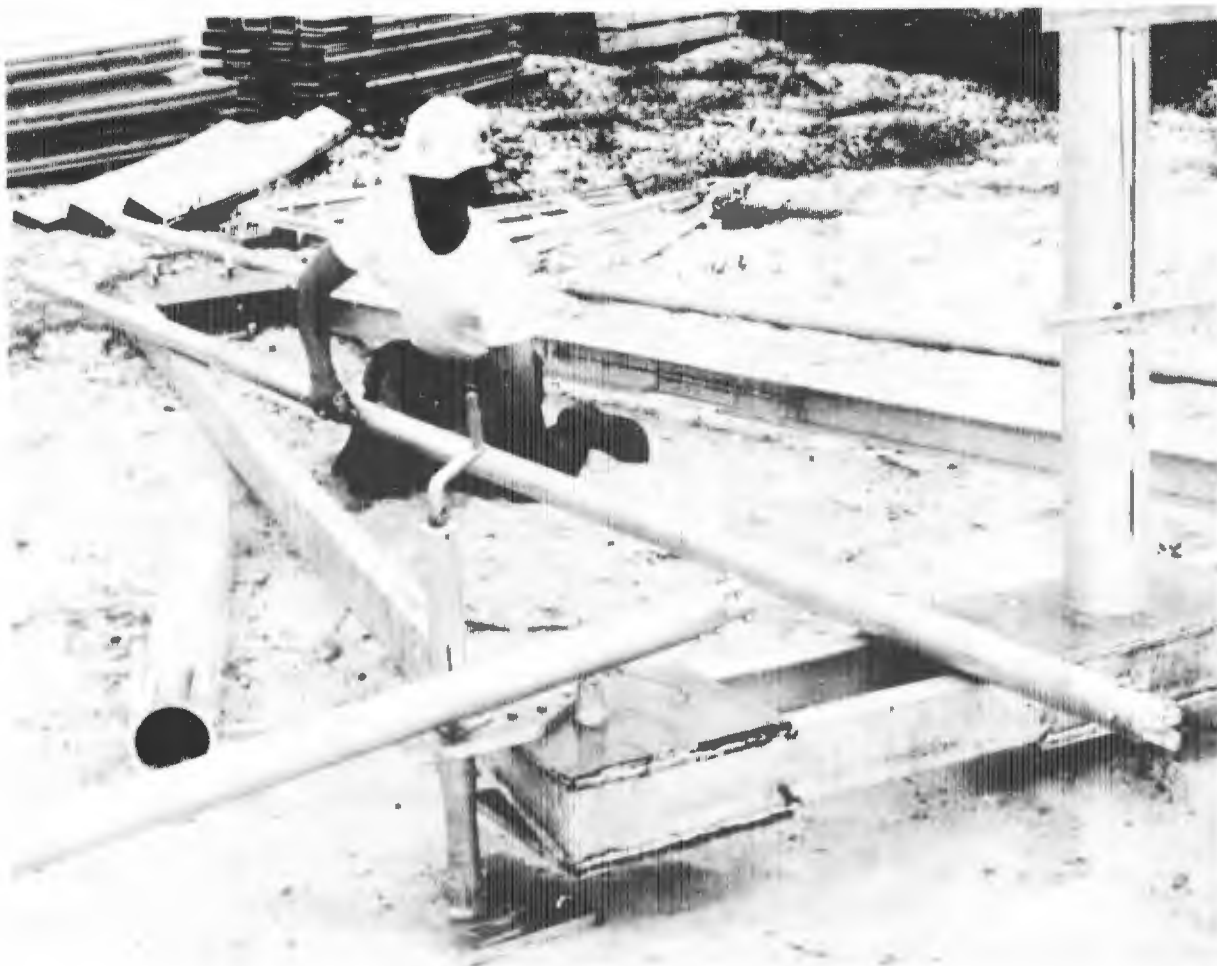
Figure 14 A-Frame Assembly

The first work effort that was undertaken was the assembly of the A-frame gantry. All the pieces were marked by the contractor for the assembly procedure. Some difficulty was experienced at this point in putting the A-frame together, in that the holes that were predrilled for the components provided a very snug fit. Also, bolts and nuts were required for the assembly. This problem could have been overcome by fabricating interchangeable components for the A-frame and providing lock-pins to fasten the sections together instead of the bolts and nuts.

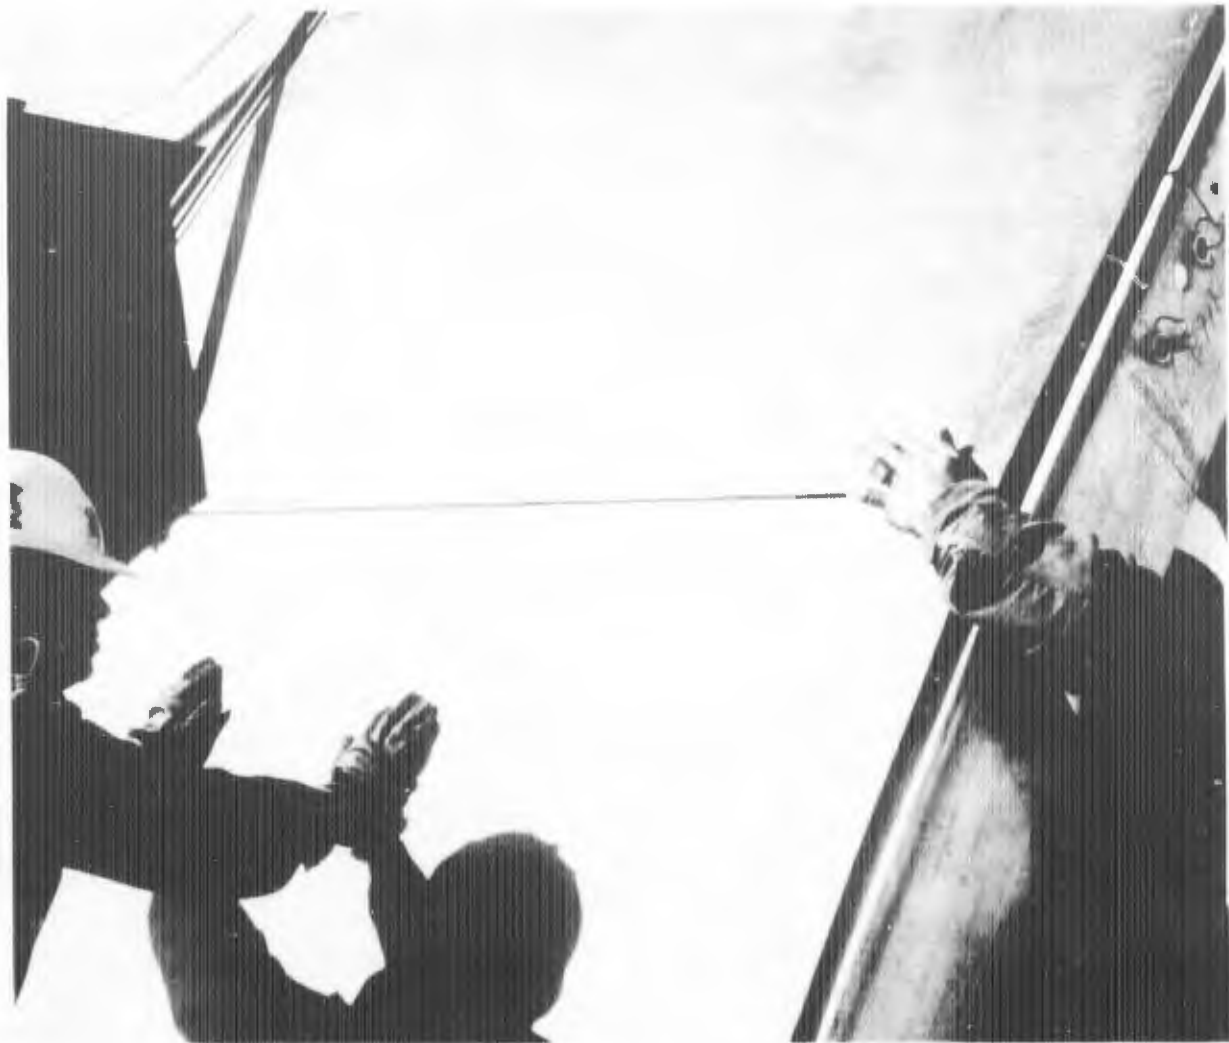
Figure 28 Pressure Being Applied to Panel Corners to
Start on Arch Beam Track

In Figure 28, the personnel were putting pressure on the panel at the point where it was installed in the track. If pressure was not initially maintained at this point, the winching of the panel on the track would sometimes miss the insert in the corner of the panel. It then became necessary to reverse the cable and pull the preceding panel down to where the next panel could again be locked at the edge member and set on the track.

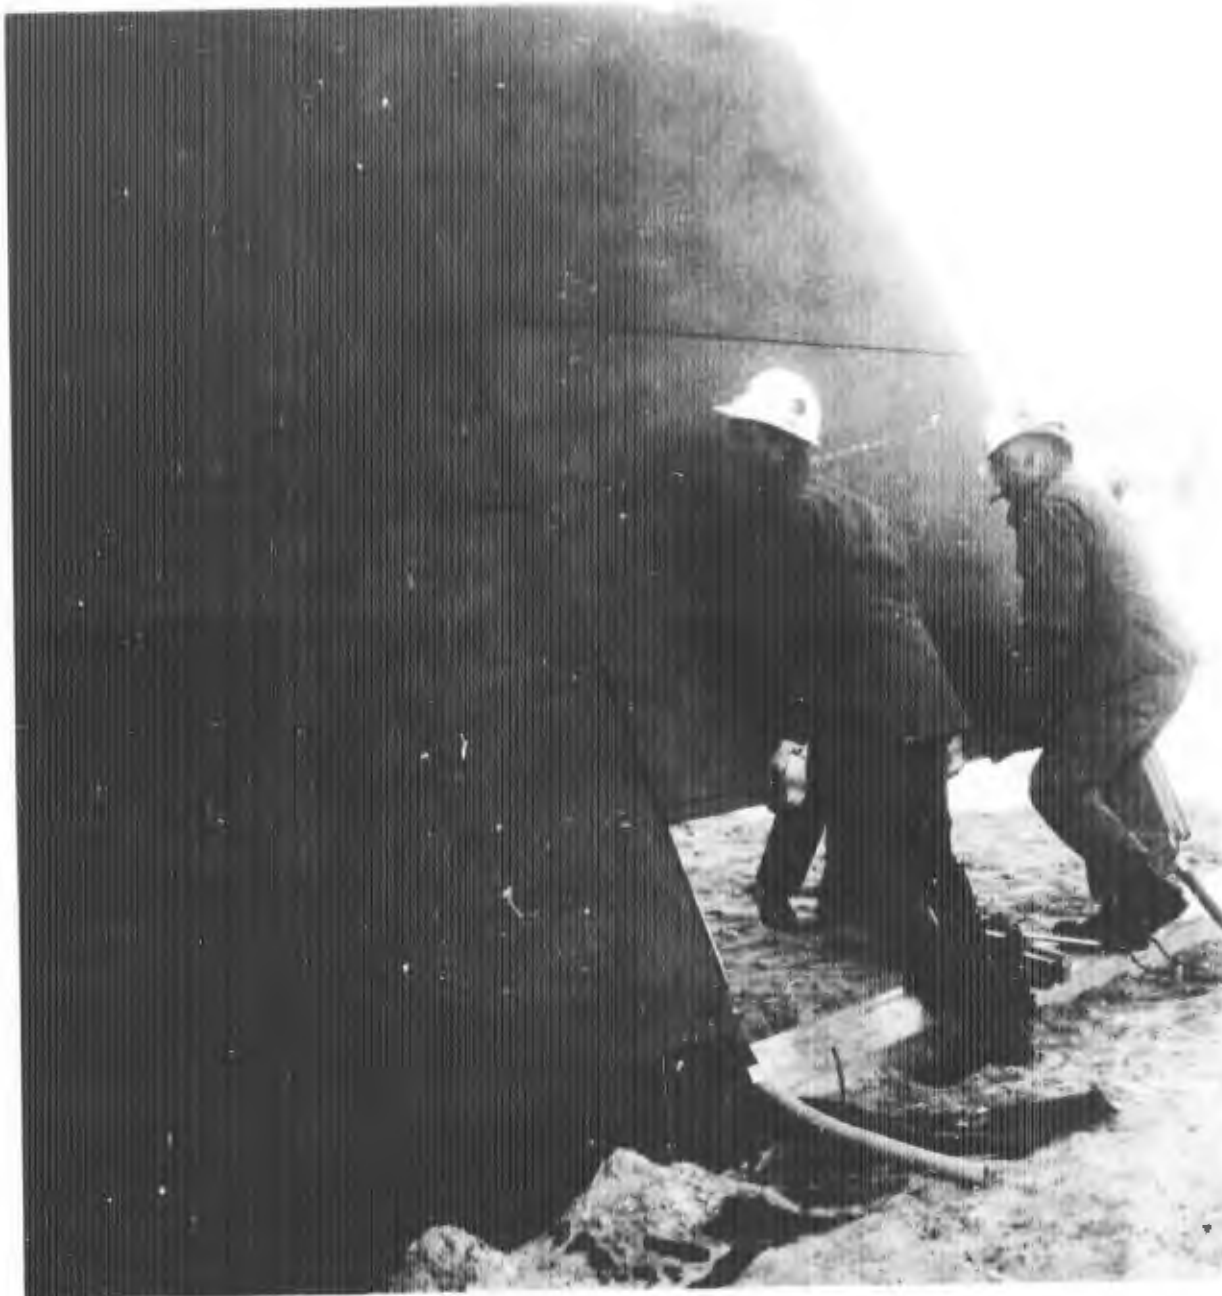
The third arch beam was then raised to the vertical position and the panels were subsequently installed. Time was reduced by 50 per cent to install the panels, partially because the track was cleaned and a 3/4 inch drill motor was used to turn the panel installation winch rather than strictly manpower. The drill worked well with only minor overheating. During the installation of the panels between the third and fourth arch beams, a manual panel insertion was attempted rather than using the panel winch. Figure 30 shows two personnel were able to

install the second panel by hand. Twelve panels were installed by hand on the third arch using five personnel pushing the panel in place. The remainder of the panels were installed, again using the drill motor.

Figure 30 Installing Panel Manually

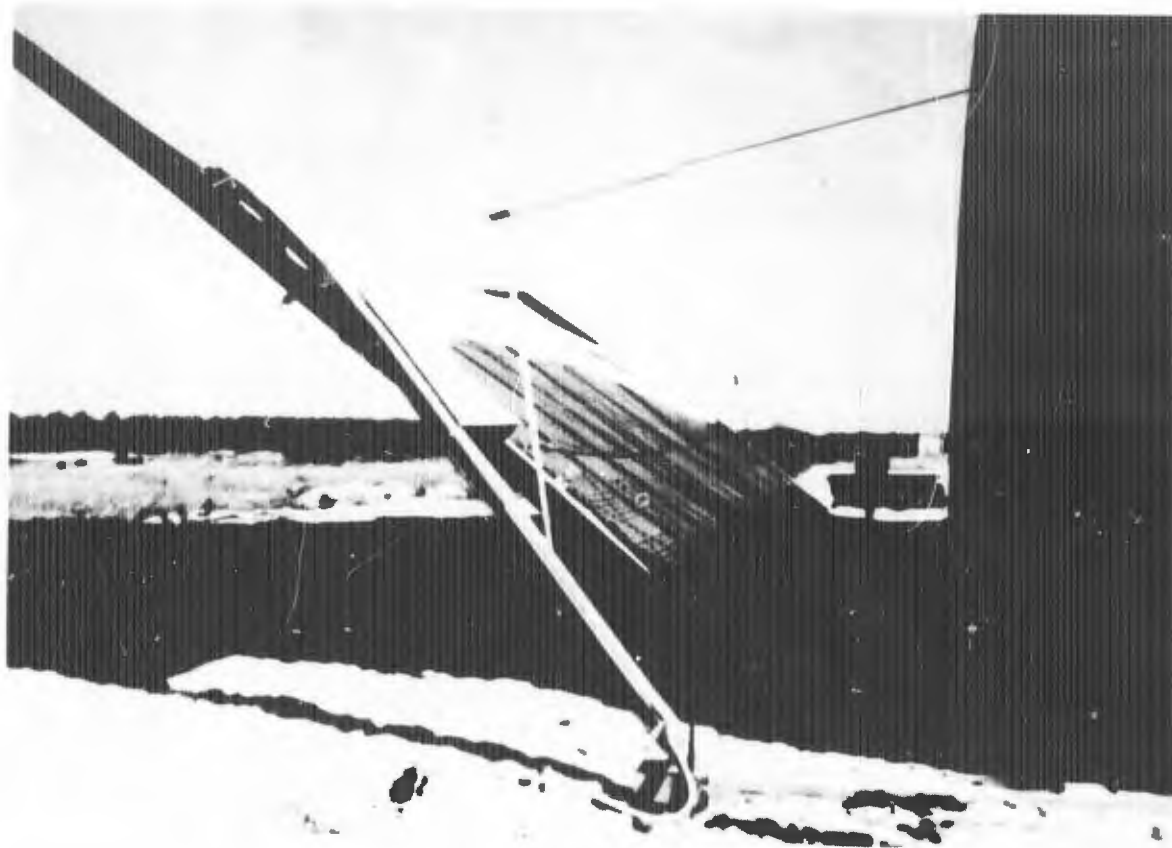
position with no problems (Figure 37). The last row of panels were then installed between the eighth and ninth arch beams. Only four panels were able to be installed by hand and then the drill motor was used. The last four panels were extremely difficult to install and the work had to be stopped after each of the panels were installed to cool the motor.

Figure 37 Vertical End Wall Being Pulled to Vertical Position

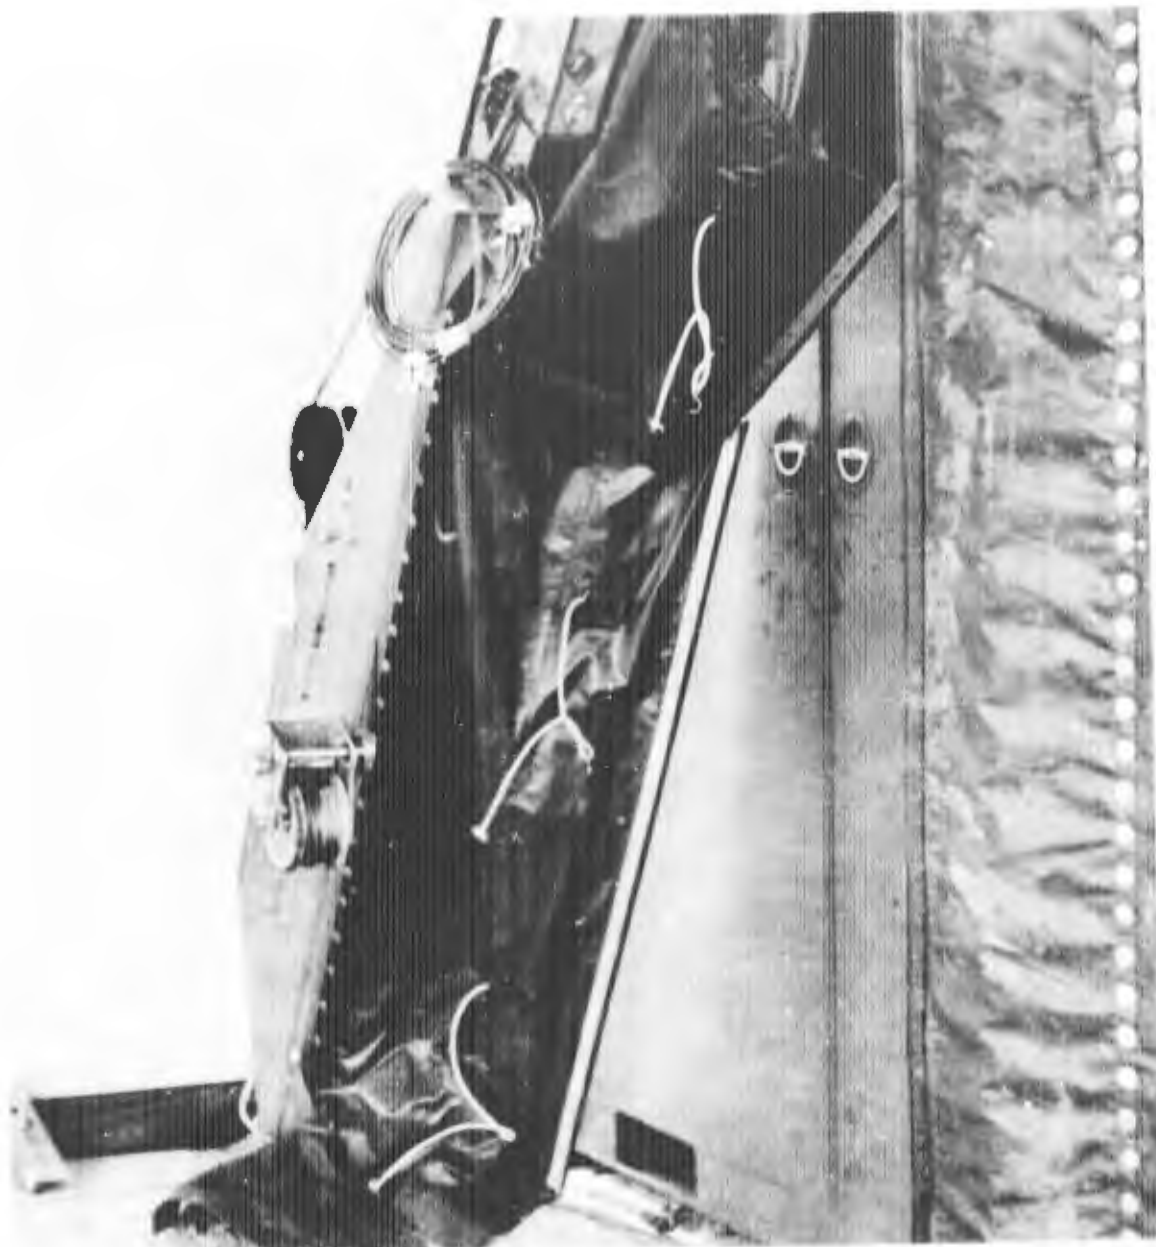
Figure 40 Fabric Door Cable Winch, Container Side of Shelter

arch beam to the container. This system was satisfactory but did not provide a total weather-proof shield. Some water did come down between the container and the transition piece. Also during the 7-month period of the test, the base channels spread a little and the door from the container was not able to be fully opened because of the movement. The exact positioning of the container was required in order to open and close the door into the shelter (Figure 40).

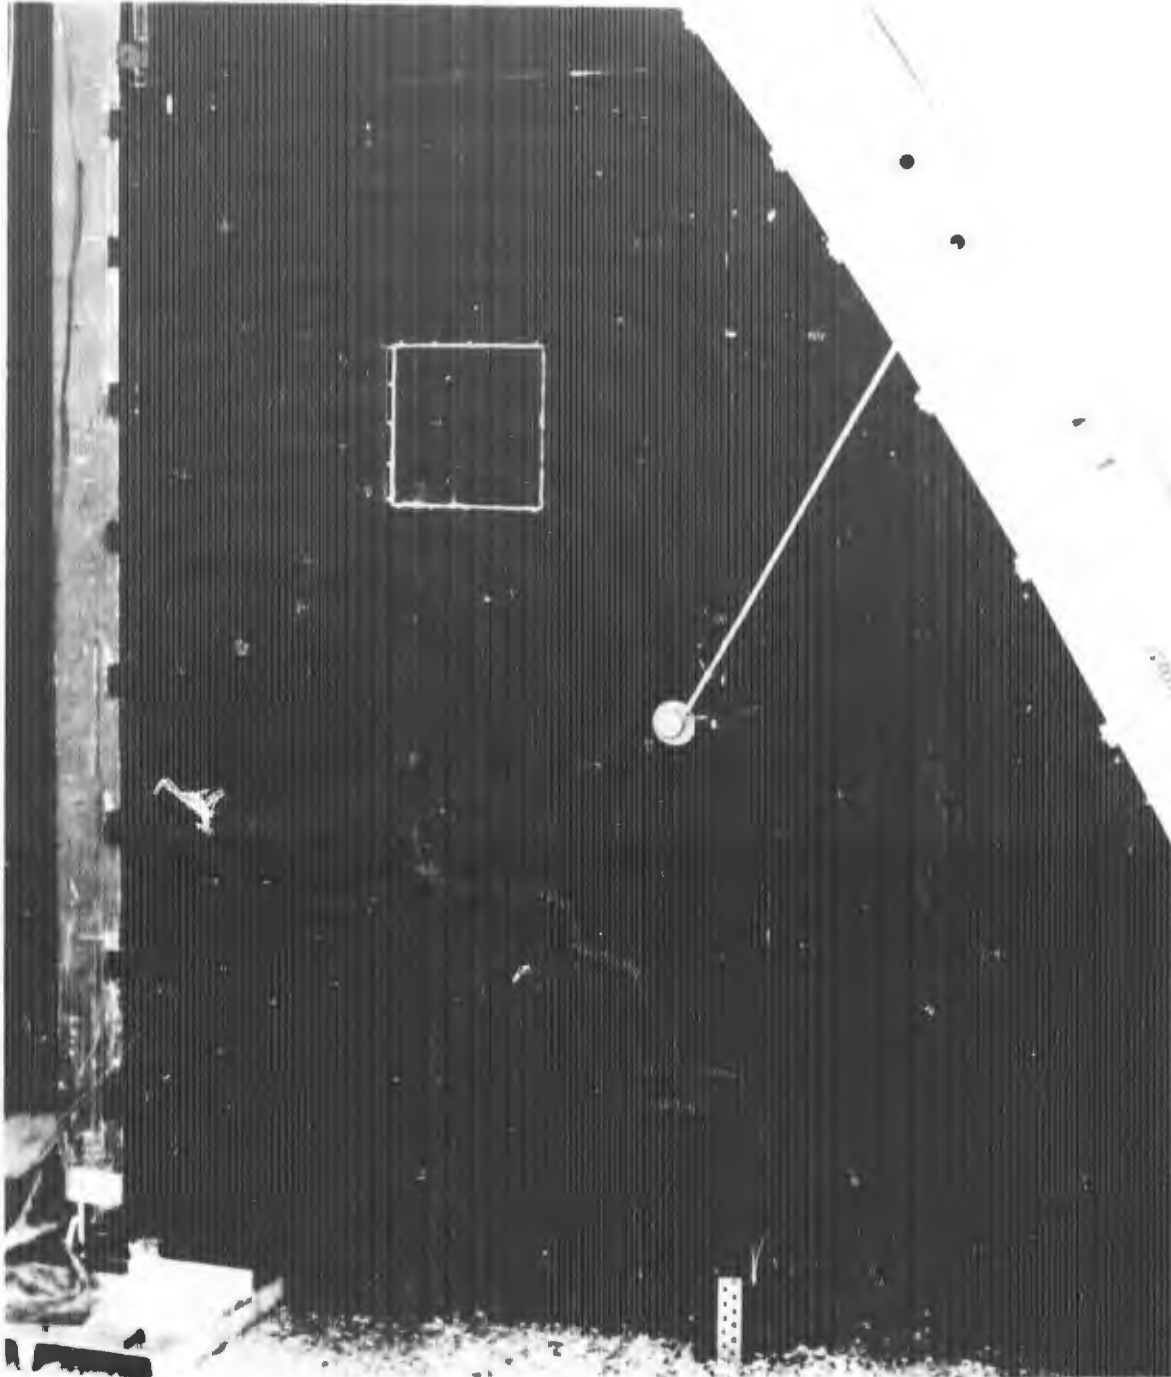
The door has a ground cloth attachment similar to the side panels and fabric door to prevent the elements from entering the shelter during extreme weather conditions. It attaches to the bottom panel on the door and did not provide any obstacle for opening the door. The closure panels at the outside sections of the arch between the door and the extreme outside edge of the shelter were fitted with corrugated panels and personnel doors. These panels were attached to the arch beams with the use of J-bolts and hinge pins. The method of securing these panels was satisfactory initially; but, during the extended time the building was erected, the constant wind caused loosening of these connections. The personnel door did not fit properly in the panel. This was due again, to the unlevel area at the erection site. Had the ground elevations been the same, the door would have fitted properly (Figure 56).

Figure 56 Personnel Door, Metal End Closure

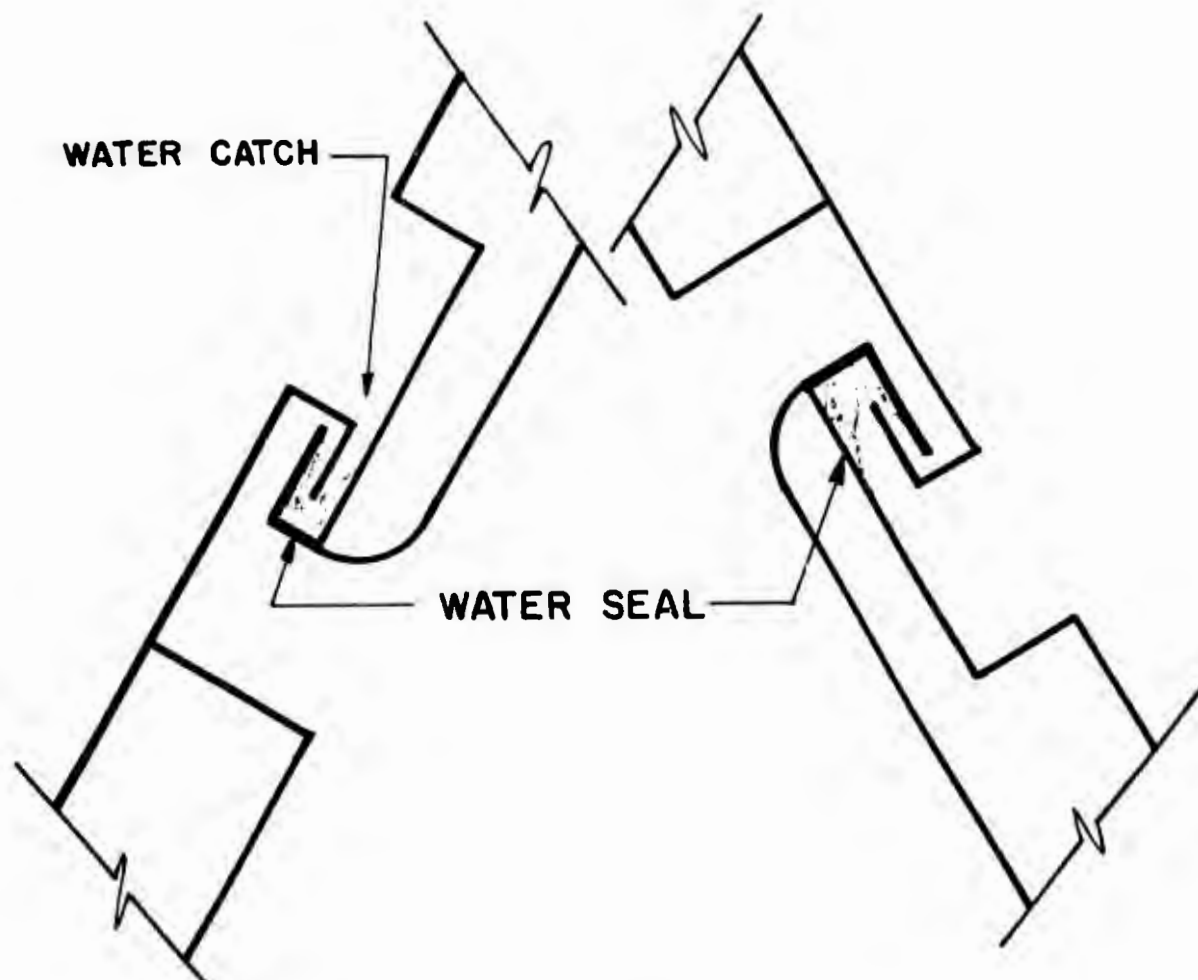
beams at the two lower areas by cutting out an additional piece of aluminum to enlarge the hole and thereby allow more water to fall into the arch beam. This modification was made only on four beam sections and would be required throughout the whole building in order for all arch beam segments to be interchangeable. This modification did resolve some of the problem, but it was evident that water was still coming in the building at the track on the arch beam where the panel insert did not completely enclose it. Another problem that was noted was that it made a difference on which side of the shelter the water was allowed to run down at the panel to panel connection. The locking joint on the panel, if it were overlapping down, carried

the water off much better than if the lock joint were turned upward to catch the water as it came down over the panels (Figure 60).

Figure 60 Detail of Panel to Panel Joints on Each Side of the Shelter

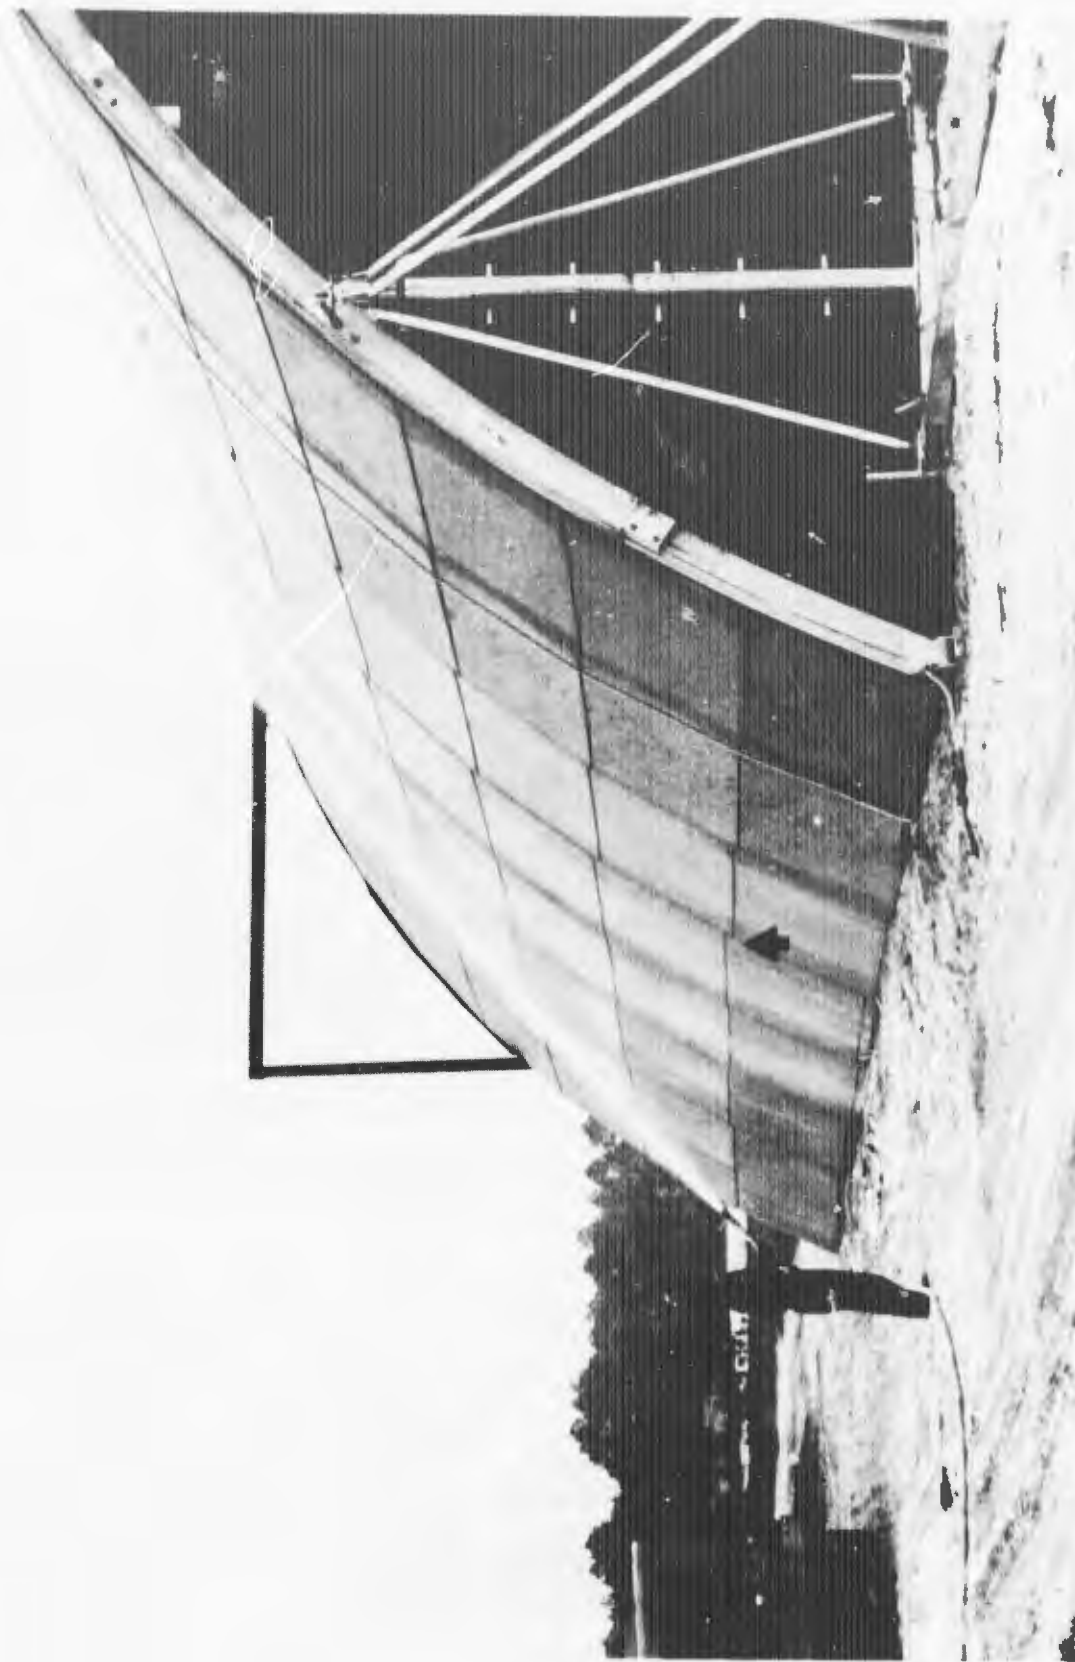
tensioning in the afternoon did decrease this problem. One panel did separate at the panel to panel connection in the middle of the arch, although the ends of the panel were still joined. This, of course, allowed large volume of water to come into the shelter. Figure 61, is a typical example of the water testing that was accomplished on the building. One can observe that the panels are not in a horizontal line along the length of the building. This was due to the different ground elevations of the base rails.

Figure 61 Water Testing on the Shelter

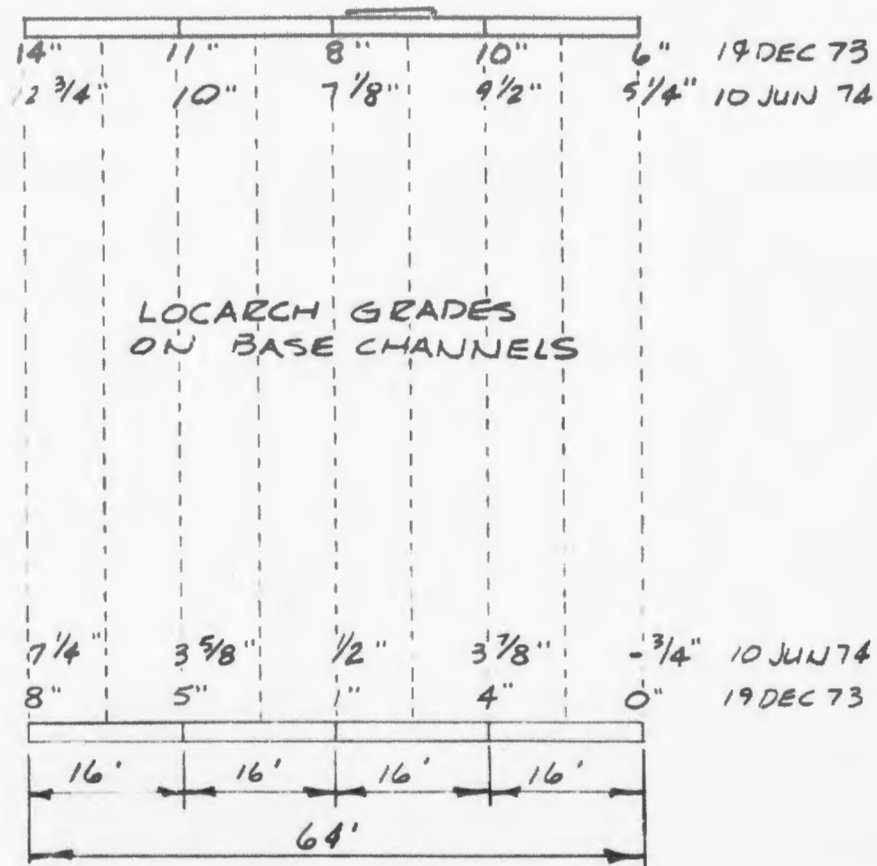
Figure 62 Elevations Taken on Base Channels During Six Month Test Period

Elevation of the base rails was taken immediately after the first erection and was again taken before the building was disassembled. Winds up to 60 mph were recorded on the wind measuring device from the south, southeast and east. The building did not experience any undue difficulties as a result of these winds. Figure 62 shows the difference in elevations from the first erection to its final position just before disassembly. The base rails spread approximately one inch on an average over the entire length of the shelter. The anchoring cables did show signs of slack since their initial placement, but the building was not damaged and considering the soil conditions, the shelter performed quite well.

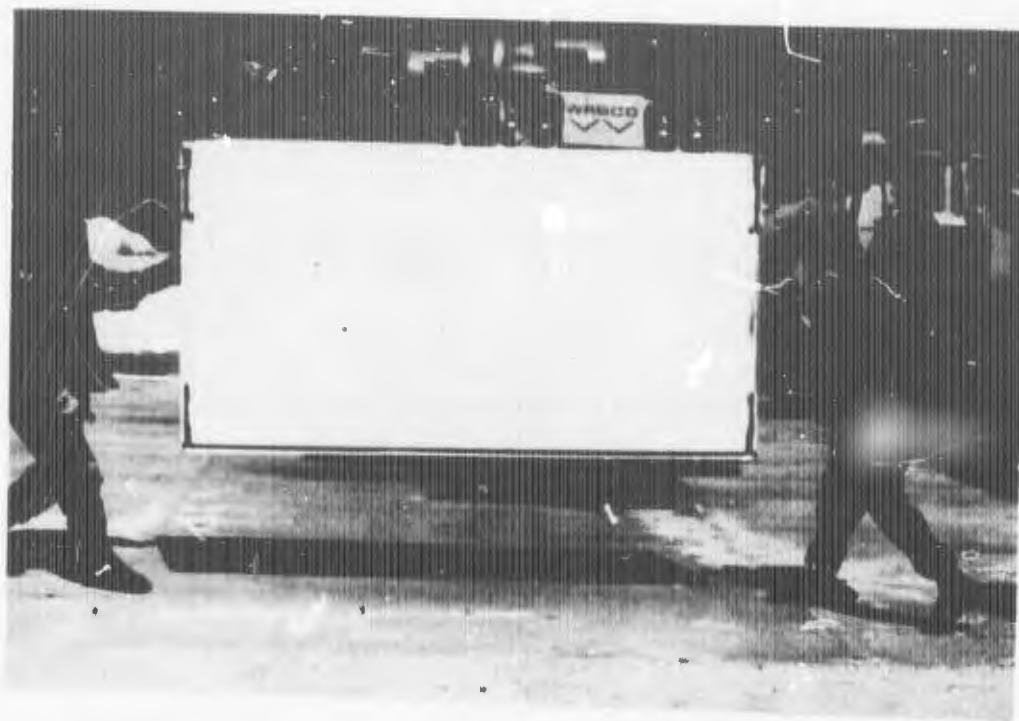
Figure 65 Panel Drop Test at Three Foot Height

in the vertical position for the drop and when it impacted the ground on the edge it fell over on a small rock. The weight of the panel falling on the rock on the concrete surface penetrated the .017 inch thick aluminum skin without any difficulty. This was noticeable throughout the test phase of dropping panels on the concrete. A surface puncture such as this would allow the water to migrate inside the panel and render it useless in a short time. If the panels were handled carefully through the erection process, no damage resulted. Under field conditions, one can assume somewhat rougher handling than the panels experienced during the test. The thin aluminum skin, the edge members and panel inserts would most likely undergo a great deal of damage during the life of a shelter.

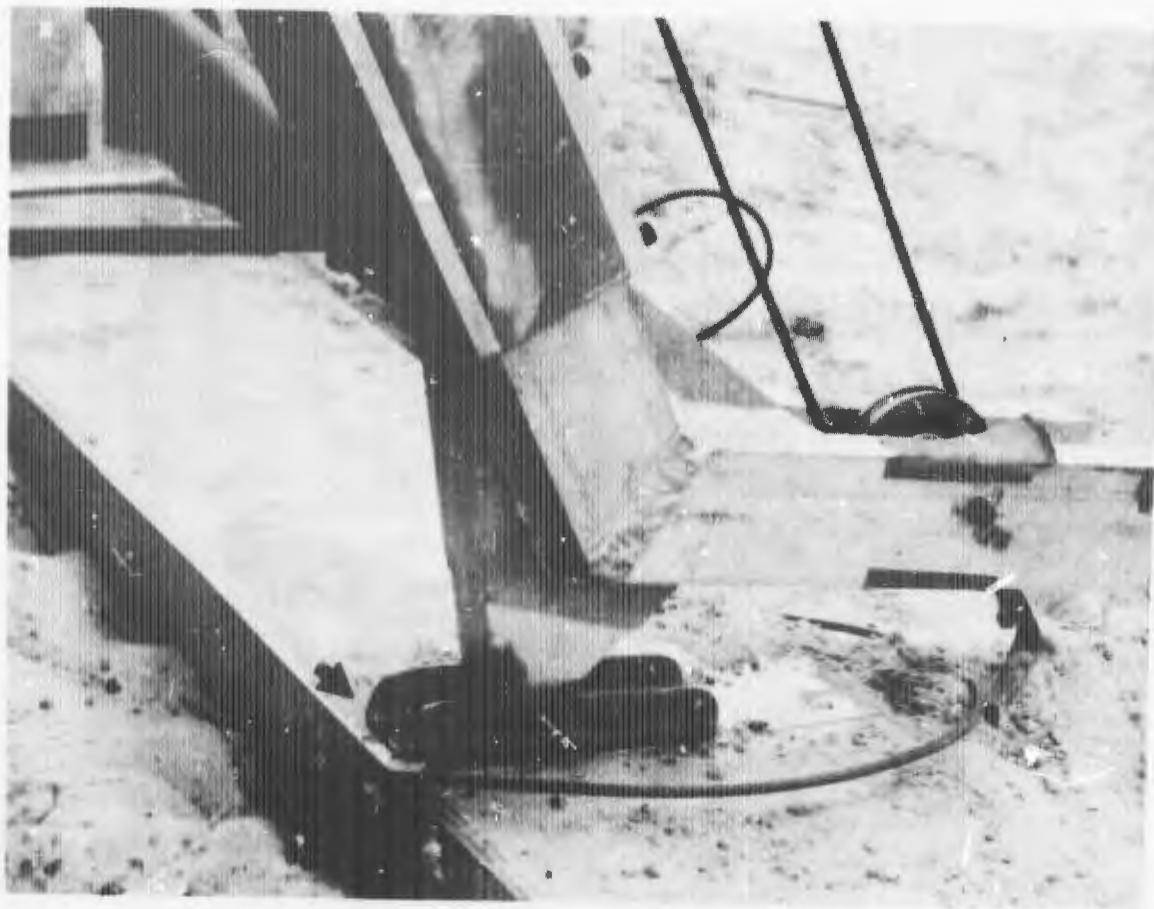
Figure 71 Base Attachment Raised During Panel Removal

much difficulty with the exception that the foot of the T-bar installation winch kept jumping off of the bolts that were prepositioned on the base channel. This problem had not been encountered before during the installation because the force exerted through the winch pushed the panels upward and forced the foot down onto the base channel. In removing the panels, the force was reversed and tension was exerted in the cable to pull the panels out of the arch beam, and creating a lifting action to pull the foot off the base channel. This was easily corrected by installing bolts that could be tightened down to

hold the foot securely on the base channel (Figure 71). After all the panels were removed, it was observed that there was no appreciable damage but there was a build up of sand in the panel inserts that rode over the arch beam tracks. The sand was mixed with the silicone lubricant and had become almost a greasy paste-like substance. These deposits apparently built up over a 3 month period, since the time that the building was first erected (Figure 72).

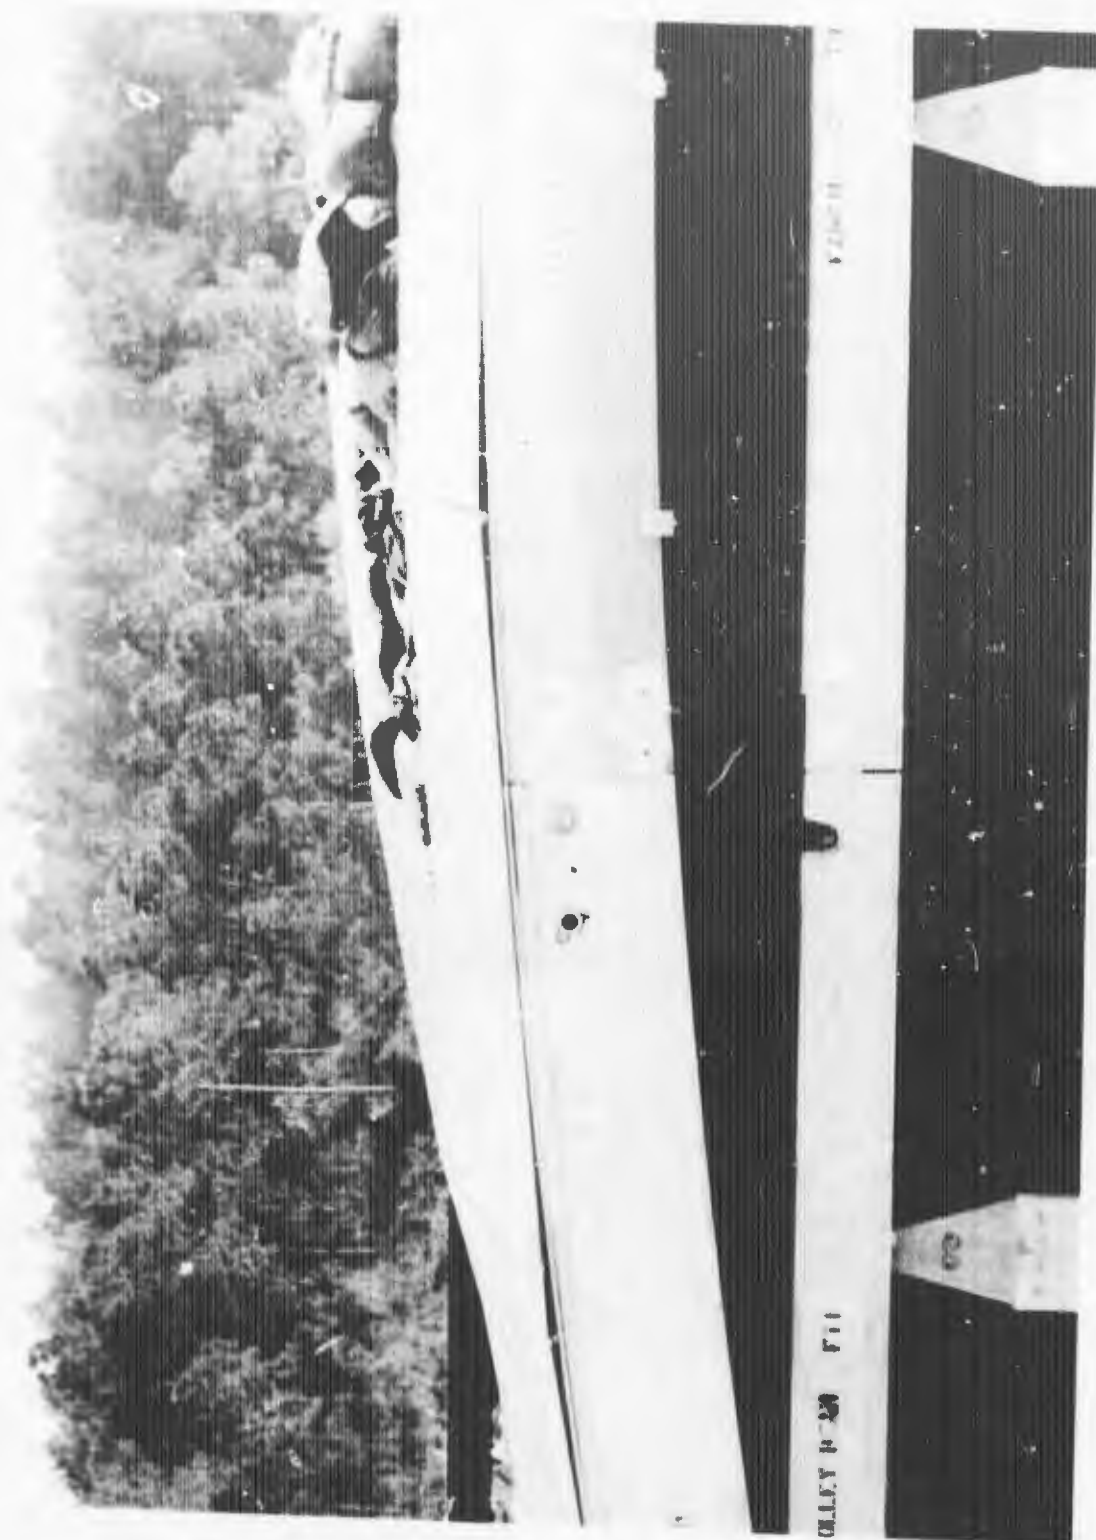
Figure 78 View From Fabric Door End of the Shelter With Sandbag Load

an end view of the shelter illustrating how the test area deflected. The top of the second layer of sandbags was almost level with the elevation of the panel at the end of the shelter.

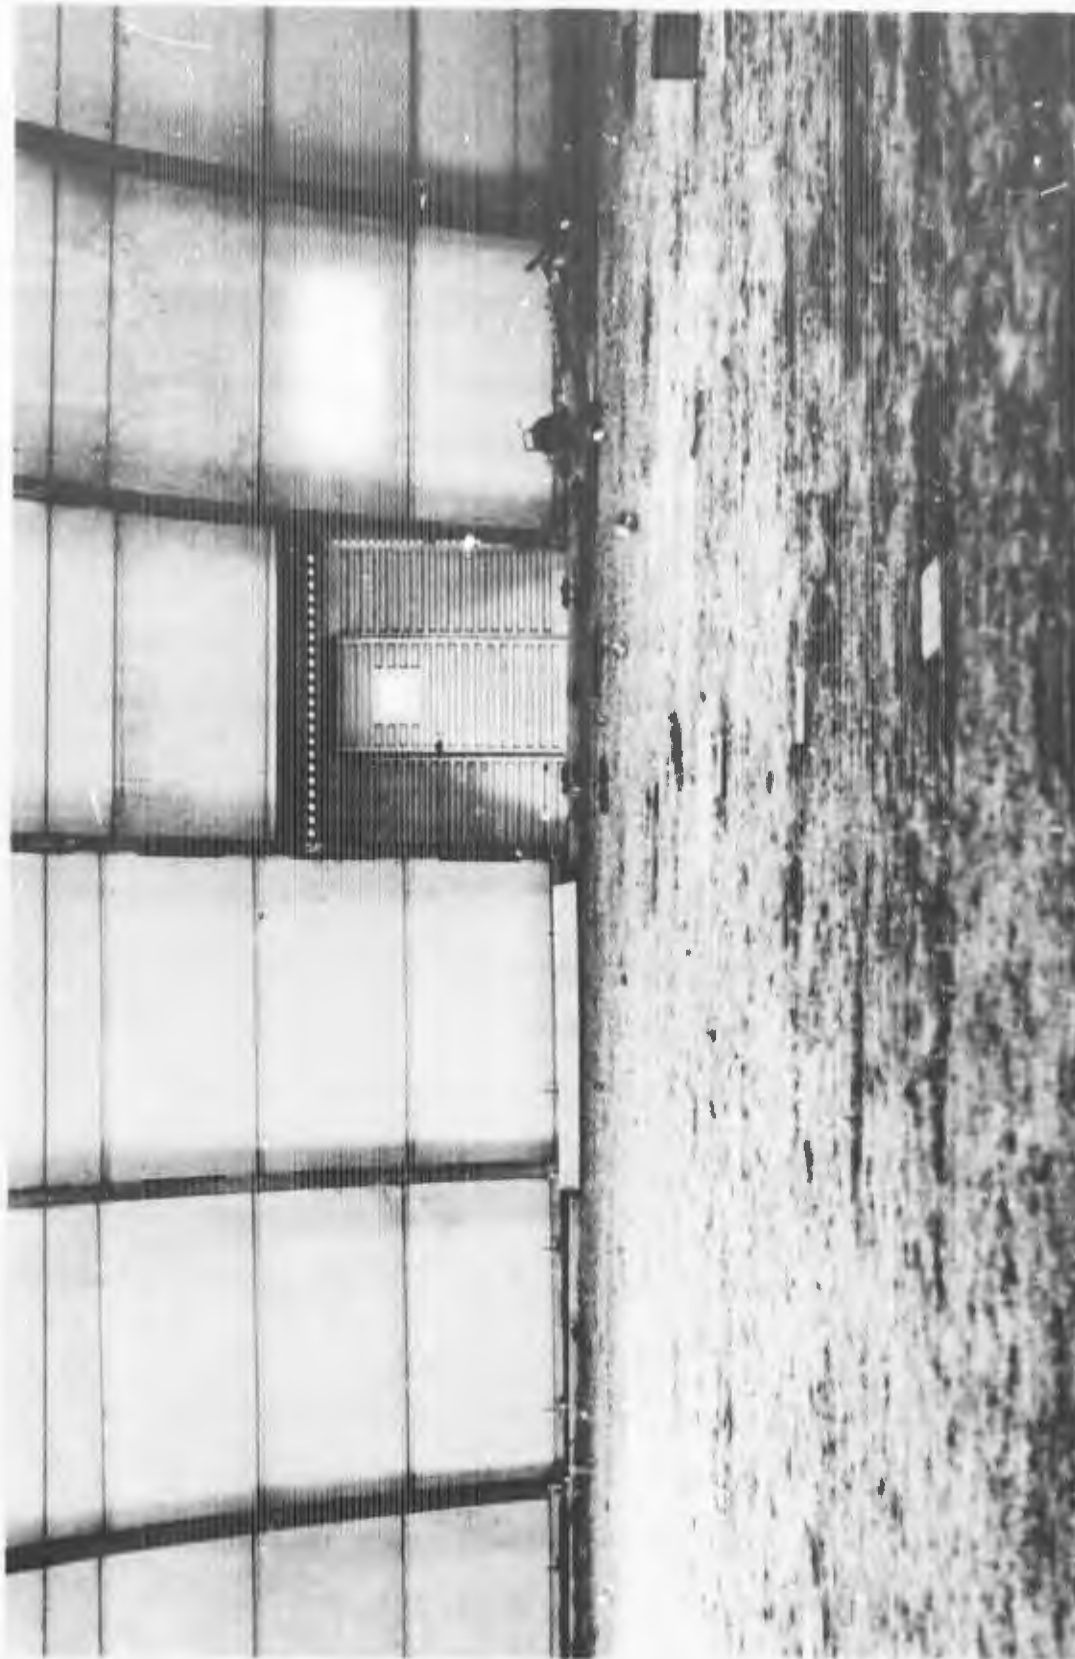
Figure 86 Overall View of Data Collection Points and Deflection
Across the Arch Beams

increasing the load on the building. After the rain had subsided measurements were again taken to observe if any additional deflection had occurred. Figure 86 shows how the data collection points were located and the deflection that occurred in the building. Immediately after the measurements were taken with the saturated sandbags, the building was unloaded and measurements taken again to record the deflection that remained in the shelter. Table VIII is a summary of all the deflections that were measured during the test. Visual observation indicated that there was no permanent damage to any of the components of the shelter. The center arch beam did not undergo the deflections as in the previous test. Only a fractional amount of separation at the center joint could be observed. The erection pins remained in the round shape in all the arches. Only one panel separated at the panel-to-panel joint, whereas in the previous test four panels separated.

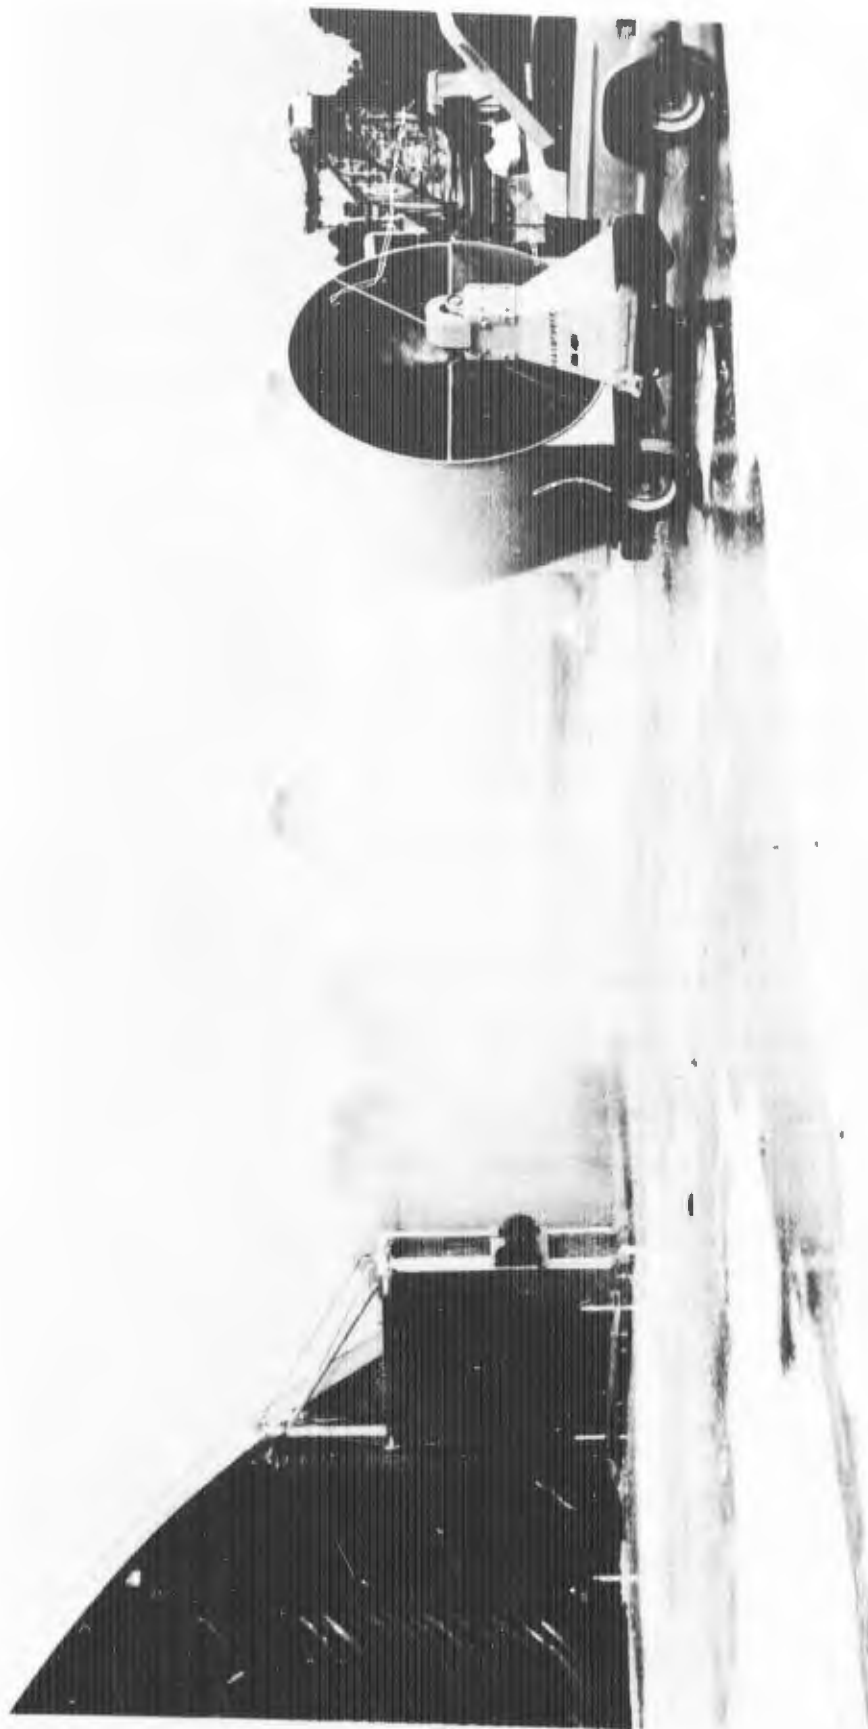
Figure 87 shows the wind machine in operation while testing the container for water tightness. Some leakage was observed at the center rib joint of the front door and also at the left door where the erection winch was attached. As the wind machine was allowed to run, some water accumulated inside the container and began blowing back into the interior of the shelter. The rear door to the container was left open during the test to record observations inside the container.

Figure 87 Wind and Rain Test on Container
